Maryland Inventory of Historic Properties Historic Bridge Inventory Maryland State Highway Administration Maryland Historical Trust

Name and SHA No. M 8 over Bennett Creek

Location: Street/Road Name and Number: Barnes Road over Bennett Creek
City/Town: <u>Damascus</u> Vicinity
County: Montgomery
Ownership:State_X_CountyMunicipalOther
This bridge projects over:RoadRailway_X_WaterLand
Is the bridge located within a designated district: yes X no
NR listed districtNR determined eligible districtlocally designatedother Name of District
Bridge Type:
Timber BridgeBeam BridgeTruss-CoveredTrestleTimber-and-Concrete
_Stone Arch
Metal Truss
_Movable BridgeSwingBascule Single Leaf_Bascule Multiple LeafVertical Lift_Retractile_Pontoon
X_Metal Girder  _X_Rolled GirderRolled Girder Concrete Encased  _Plate GirderPlate Girder Concrete Encased
_Metal Suspension
Metal Arch

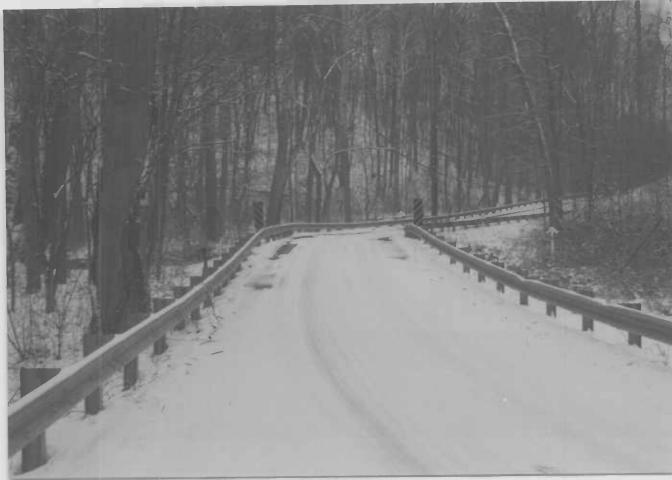
Inventory	#	M:	10	100	77

Name M8 - BARNES RD OVER GENNETT GREEK County/State MONTGOMERY MO
Name of Photographer FRANK JUHANO
Date 2 95
Location of Negative SAR
Description APPROACH NORTH
Number 18 of 36

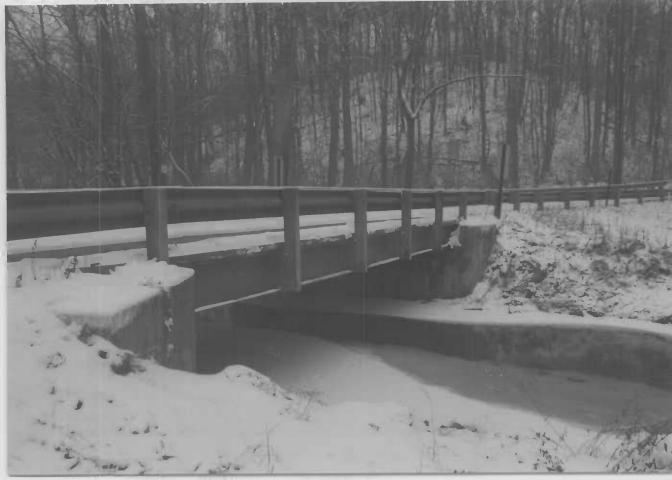
## Inventory # M: 10-77

Name M8-BARNES ROOVER BEDNETT CREEK County/State MONTGOMERY /MD
Name of Photographer FRANK JULIANO
Date 2 95
Location of Negative SHA
Description ELEVATION WEST
Number V of 3/3 4

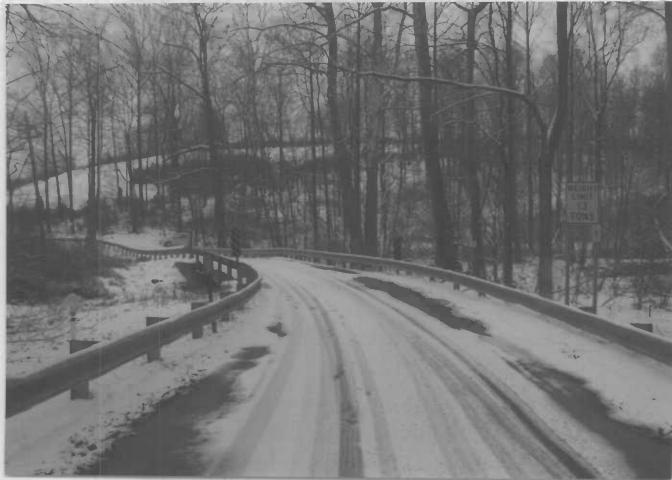
# Inventory # M: 15-77

Name M8-BARNES RO OVER BENNETT CREEK  County/State Montgomery / MD  Name of Photographer FRANK JULIANO  Date 2/95
Location of Negative SHA
Description APPROACH SOUTH
Number 1/2 of 1/3

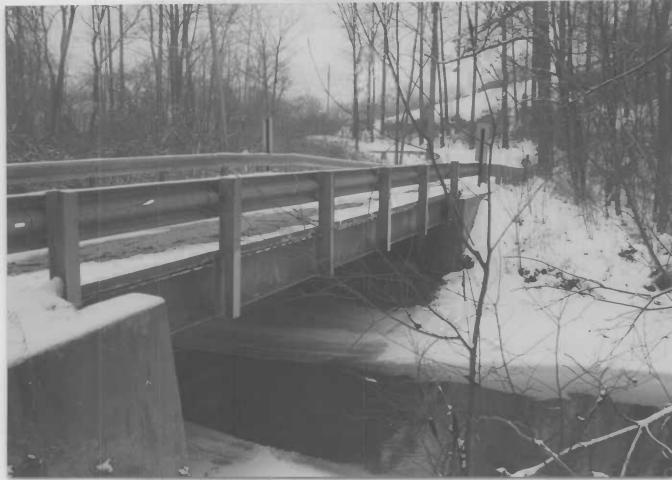
## Inventory # M:16-77

Name M8-BARNES RO OVER BENNETT CREEK
County/State MONTEOMERY MD
Name of Photographer FRANK JULIANO
Date 2 95
•
Location of Negative SHA
Description <u>ELEVATION</u> FAST
4 4
Number 43 of 33
